Debris slide at Kampung Sg. Chinchin, Gombak, Selangor

CHOW WENG SUM AND ZAKARIA MOHAMAD

Jabatan Mineral dan Geosains Selangor
Lantai 6-7, Bangunan Darul Ehsan
No. 3, Jalan Indah Seksyen 14
40000 Shah Alam, Selangor

Abstract: On 21st September 2001, at about 6.00 pm, a landslide occurred on the hill slopes of Bukit Guling Ayam at Sg. Chinchin at the 8th milestone of Jalan Gombak. In this incident, two houses were damaged and one person was killed.

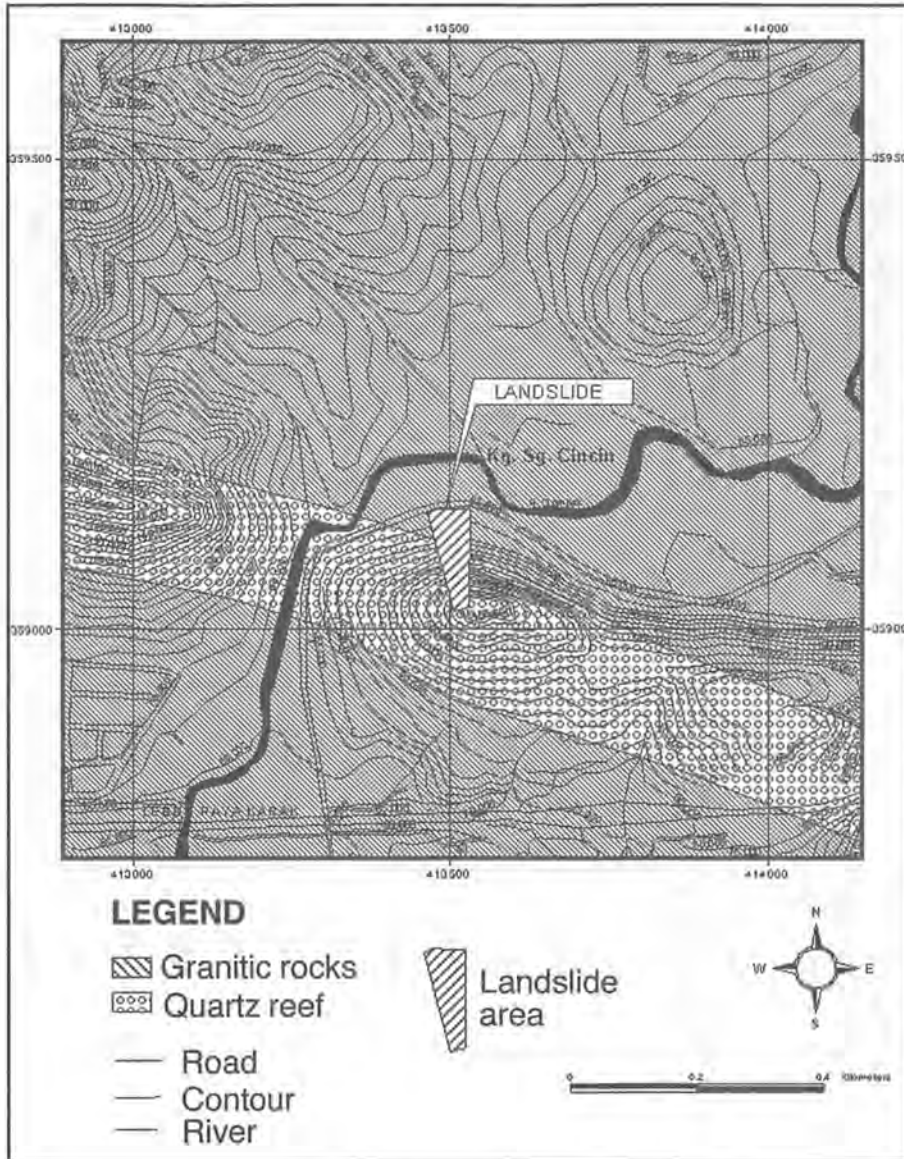
Figure 2. Geology of the study area.

The investigation site forms part of the well-known Klang Gates Quartz Reef which trends in a westerly to west-northwesterly direction (Fig. 2) (Jabatan Mineral dan Geosains, 1998). The quartz reef was observed to intrude into granite. Alluvial deposits were found in the low-lying areas at Kampung Sg. Chinchin.

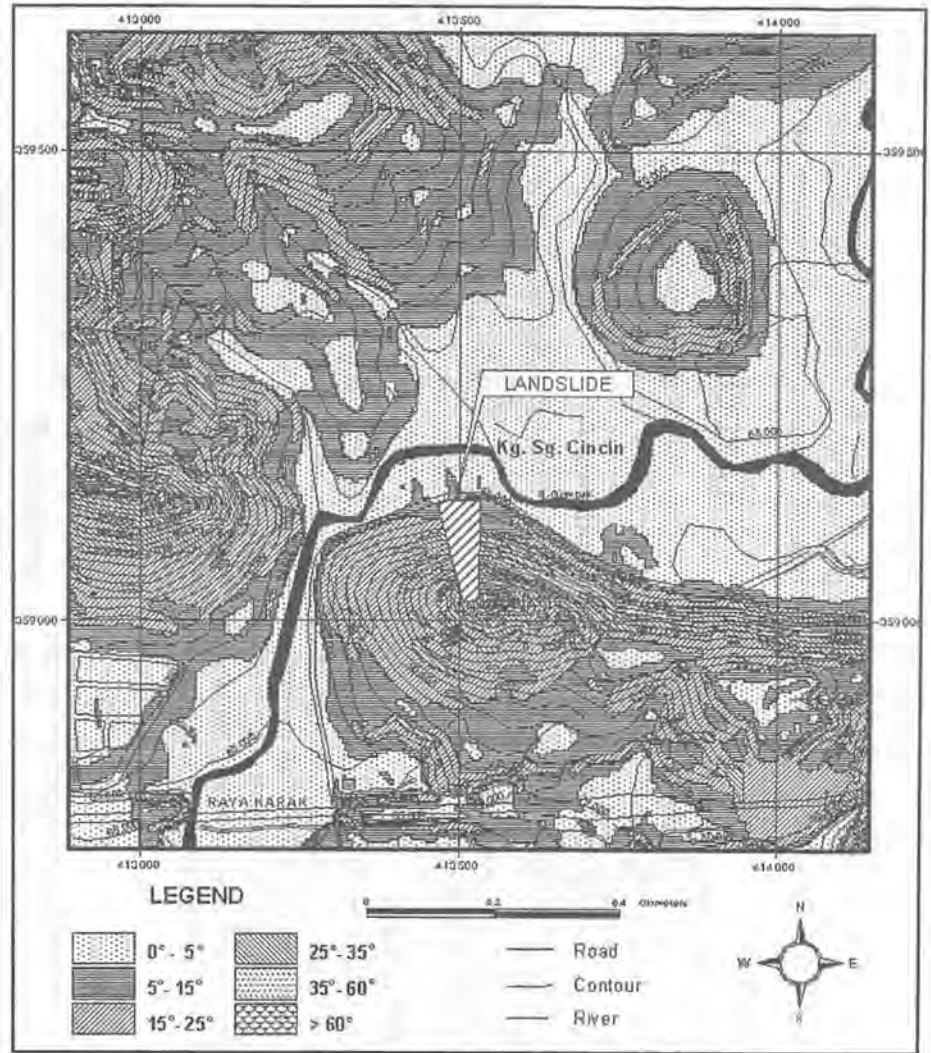
Figure 3. Gradient of slopes in the study area.

25°. The mid-slopes are more steep, with a gradient of 25° to 35° and towards the upper reaches of the slope, the gradient is about 35° to 45°. Near the crest of the hill, the slopes are more than 45° (Fig. 3).

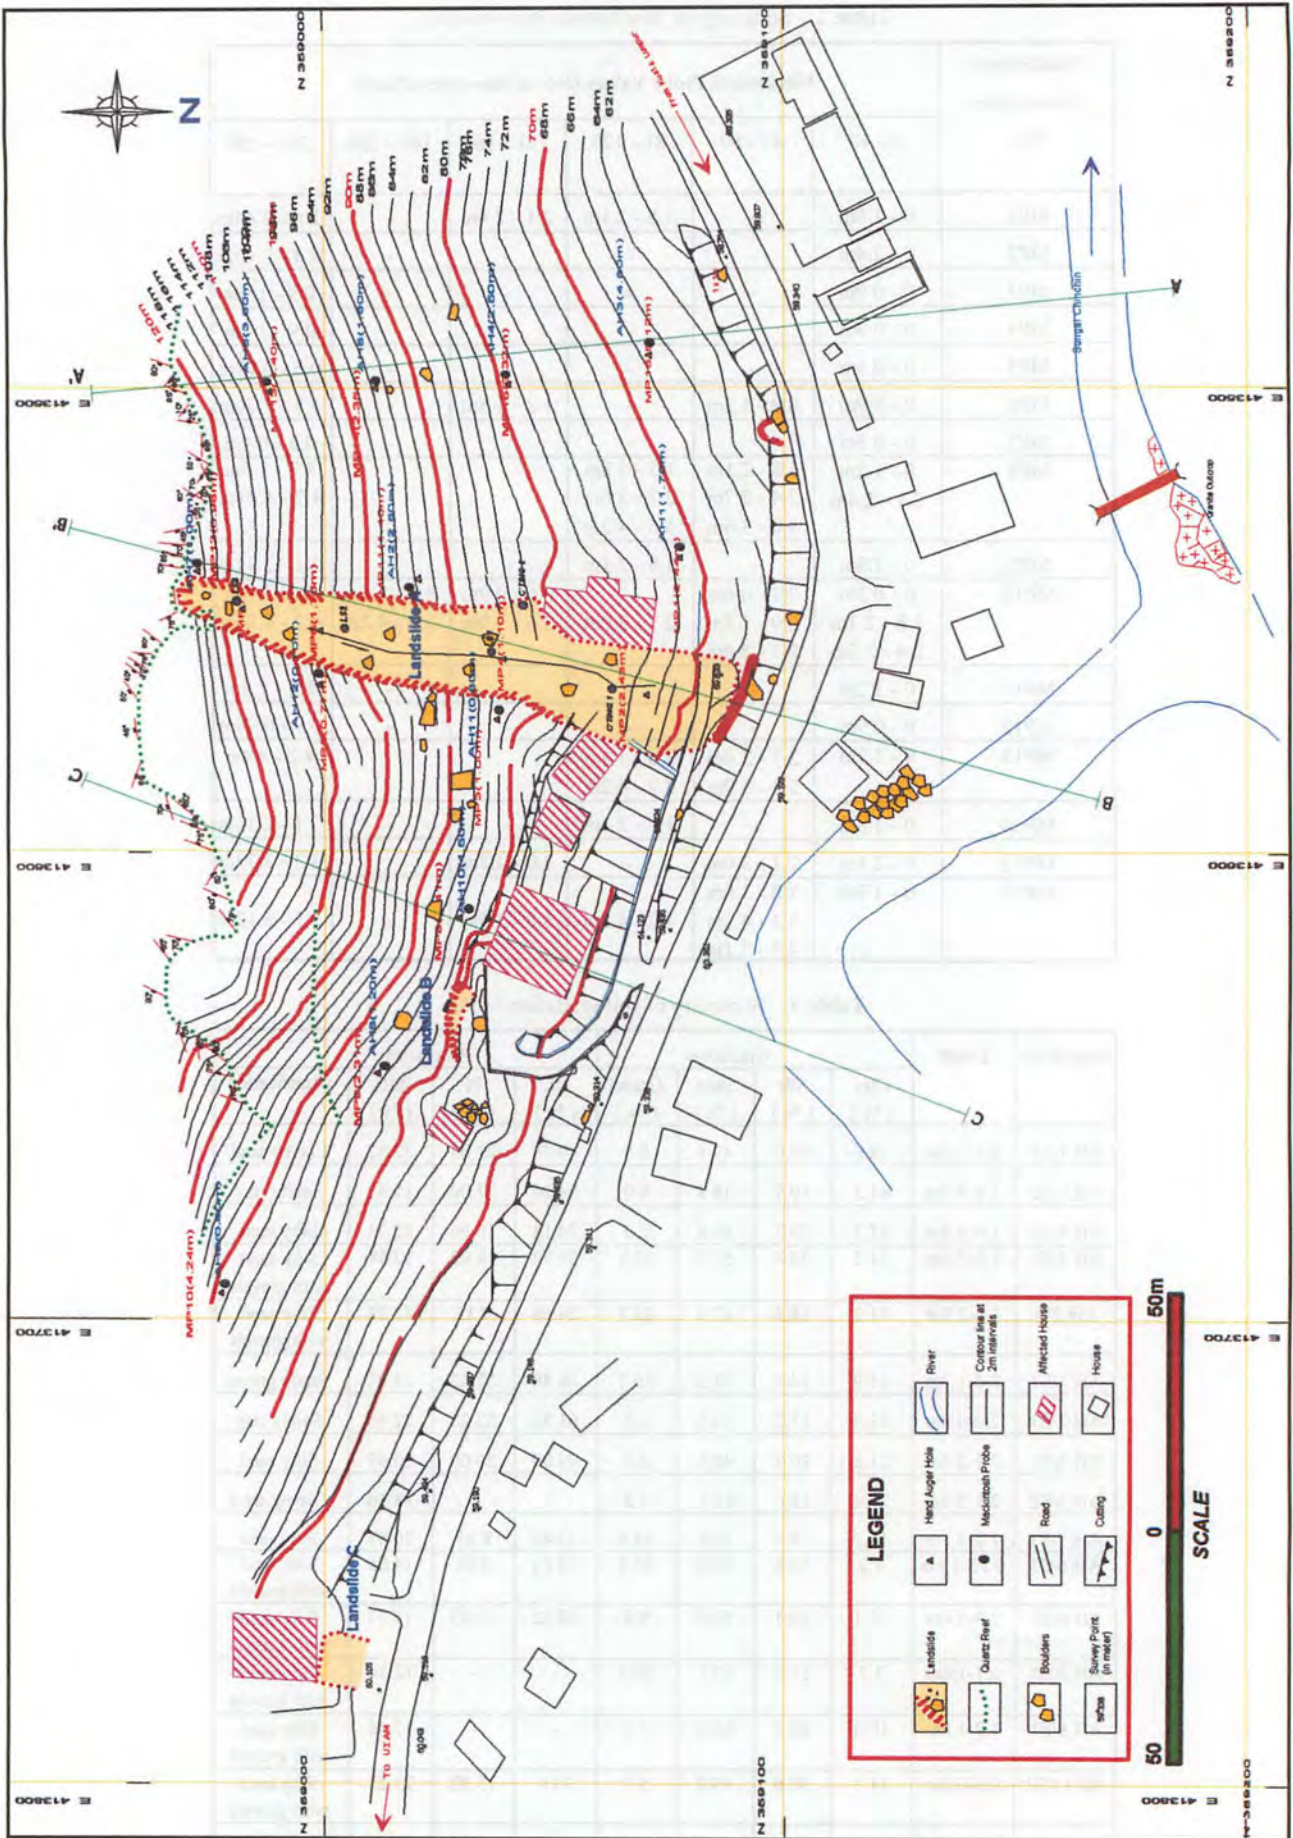
Figure 4. Surface geology in the study ara.

This was the largest landslide in the study area and the landslide had damaged two houses and caused the demise of one person on the evening of 21st September 2001 (Fig. 4). The slopes were composed of colluvium which is a mixture of loose sandy soil with numerous quartz boulders measuring about 3 m x 2 m x 1.5 m in size. The landslide measured about 15 m wide near the crown and the sides of the landslide scar had slumped about 1 m to 1.5 m. Scouring by the slide debris had left behind a scoured scar of about 120 m long and the debris were spread over another 20 m to 25 m at the foot of the landslide. The volume of slide debris was estimated to be about 4,000 cu metres.

Near to the crown of the landslide are outcrops of vein quartz which form the reef and numerous loose rock boulders were observed on these outcrops.

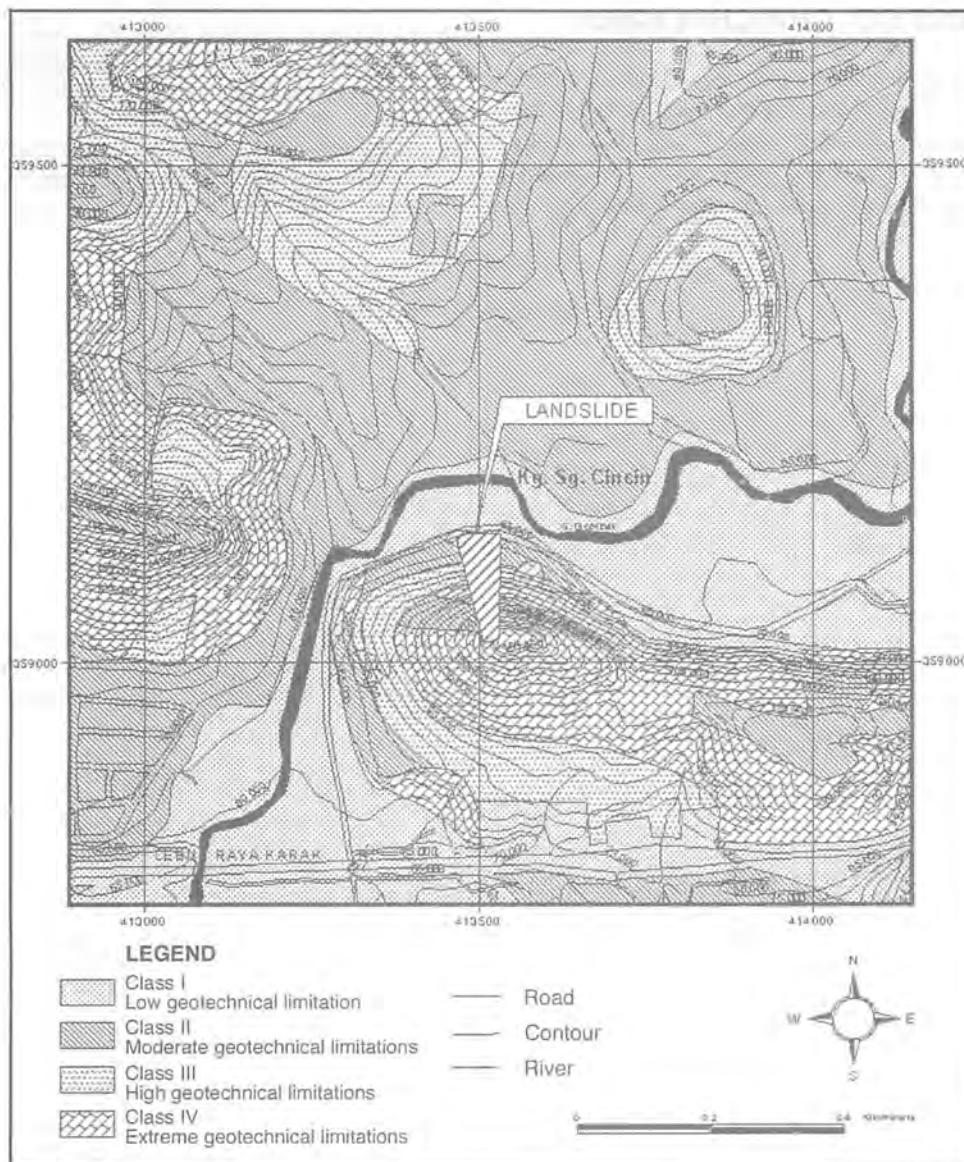
Figure 5. Construction suitability maps of the study area.

Terrain mapping of the Kampung Sg. Chinchin and its surrounding areas (Fig. 5) showed that most parts are flat to undulating, belonging to Classes 1 and 2 whereby development would not face any geotechnical constraints. However, some of the hill slopes are steep particularly in

the area where the recent landslide had occurred. These slopes have gradients of 30° to 40° and in parts, 40°–60° and besides, the slopes are underlain by colluvium. These slopes are classified as Classes 3 and 4. Development in Class 3 areas would face serious geotechnical constraints. Development should not be allowed in Class 4 areas.
