Relict Structures and Cut Slope Failures in Highly to Completely Weathered Rocks Along Jalan Tg. Siang, Kota Tinggi, Johor

TAJUL ANUAR JAMALUDDIN & MUHAMMAD FAUZI DERAMAN

Department of Geology, University of Malaya
50603 Kuala Lumpur, Malaysia

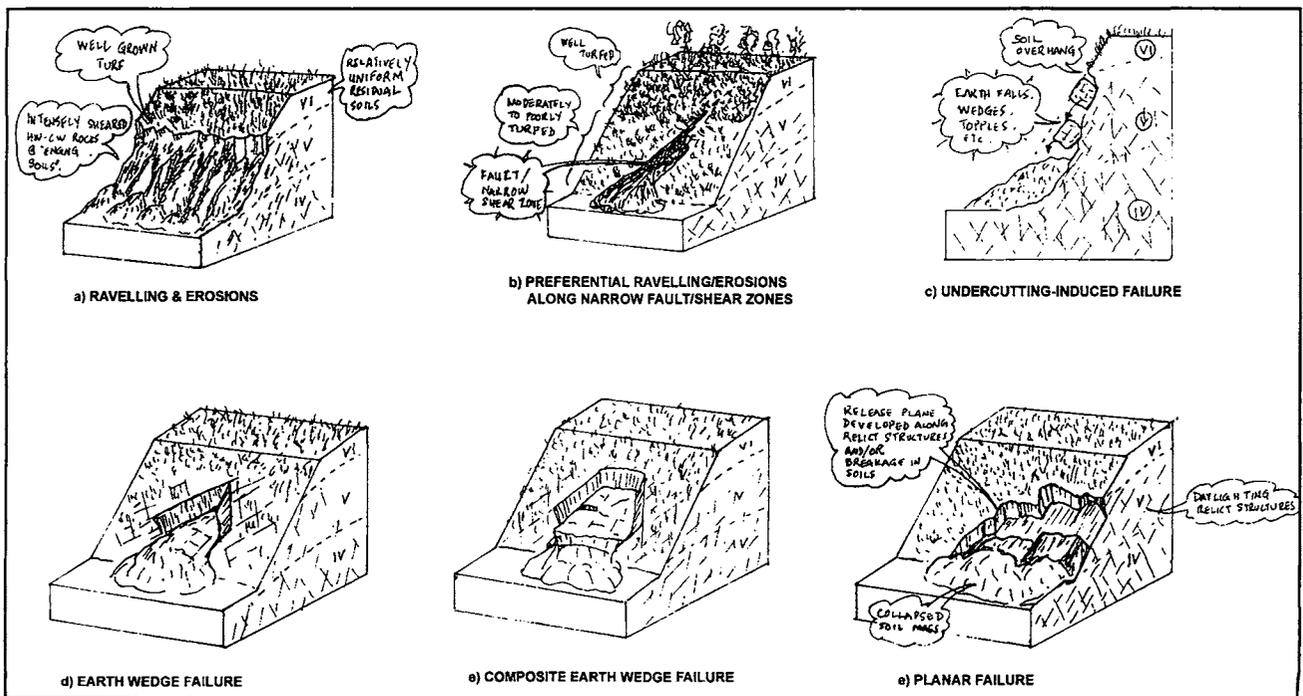
The location of failures are shown in Figure 1. Details of the geology, slope geometry, mode of failure and the likely causative factors are summarised in Table 1. Failures of cut slopes in the study area usually take place in the form of "soil" ravelling, erosion and undercutting-induced failures. Ravelling and erosional failures usually develop preferentially within shear zones, where the materials are relatively loose, friable, very weak, less durable and characteristically unfavourable for growth of vegetation (Figure 2).

Figure 2: Some common modes of cut slope failures along Jalan Tg. Siang.

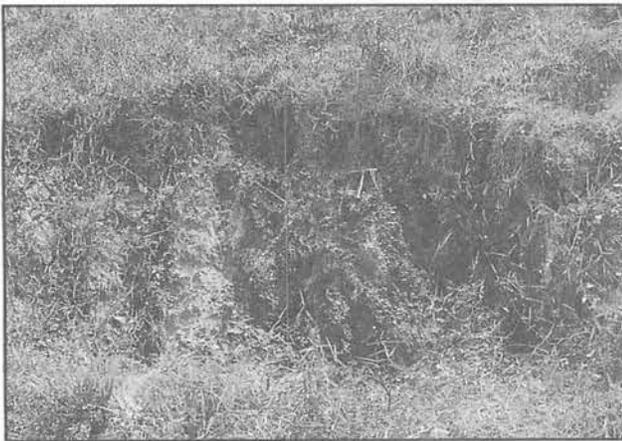
Most of the slope failures in the study area occur in the form of ravelling of the highly – completely weathered materials encountered in the shear zones (Plate 1, 2 and 3). Shear zones are usually developed in the carbonaceous metapelites (graphitic pyllite and schist). The highly sheared metapelites are often dark grey to black purplish (possibly rich in manganese). The derivative weathered soils are often loose, very weak and friable, rapidly weather and readily disintegrate and move downslope under gravitational force. The nature of the soils, with low pH conditions inhibit vegetation growth, leading to failure in turfing efforts.

Plate 1: Slope TS1 - substantial undercutting due to ravelling and preferential erosion of the completely weathered shear zone.

The direct effect of ravelling processes may not be so critical, as the downslope movements of the disintegrated materials are relatively slow. However, in the long term, ravelling may cause substantial undercutting and result in the creation of overhanging soil mass. The failure of the overhangs is of prime concern because the undercutting-induced failures are usually of large scale.

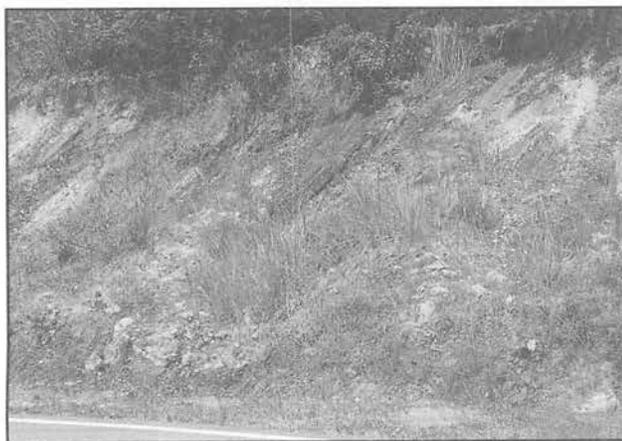
Plate 2A: Planar earth slide along the outcropping relict foliations. (Slope TS2-B)

Planar failure is not necessarily preceded by slope undercutting. Slopes cut parallel or sub-parallel to the strike, and steeper than the dip of the daylighting foliation planes, can lead to planar failure (Plate 2). The mechanism of the failure is virtually similar to those of planar failure in rock slope. In rock slope, planar sliding requires some orthogonal sets of joints as release planes for the rock slab to slide, but in soil slope, this condition may not be a requirement. This is mainly because the release plane for planar sliding to occur may develop within the soil material itself. The detachment or release planes can be readily developed when the down pull weight of the earth slabs exceeds the tensile strength of the soil material. This condition is favourably accomplished during or after heavy and prolonged rainfalls, when the soil is saturated. This is aggravated by increased pore water pressure along the foliations. In such condition, the shear strength is drastically reduced and rapid downslope movement result in the originally tabular-shaped failed mass collapsing and spreading over the footslope. The nature of the relict structures, along which the sliding plane developed, can be clearly seen in the failure scar (e.g. Plate 2A and B).

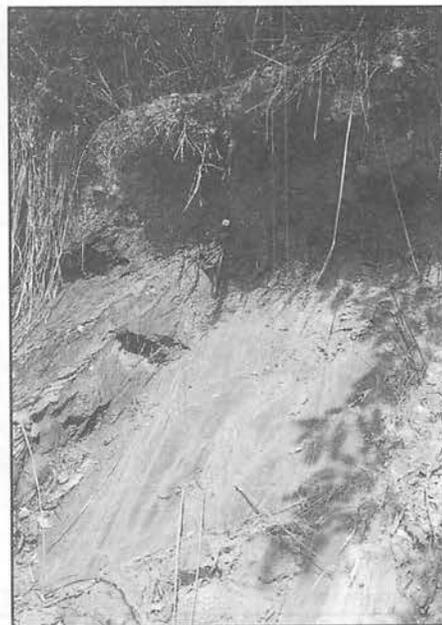
Plate 2B: Closer view of the above; showing the nature of the relict discontinuities, which control the failure.

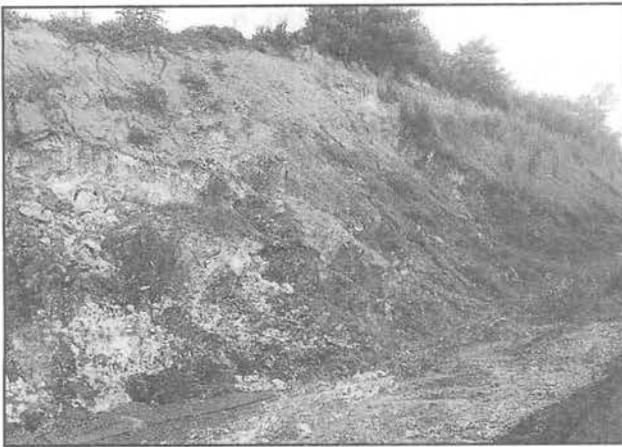
12.	3			TS5-C	Ravelling, Gully erosions & Earth falls	W: 10m H: 15m D: 0.3-2m	Interbedded phyllite, quartzite and slate	Shear Zone	IV-VI	Moderately turfed	Plate 3

Plate 3A: Slope TSS-C - Ravelling and erosional failures in the completely weathered shear zone, leading to earth falls in the upper slope section.

Once developed, the resulting effects of gully erosions are often detrimental, unless immediate mitigation and protection measures are undertaken. The eroded surface should be backfilled and turfed. All surface water and runoff should be diverted away from the slope by installing suitable surface and subsurface drainage.

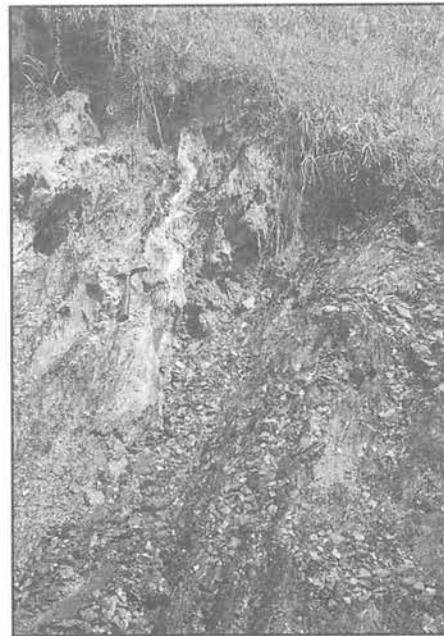
Plate 3B: Closer view of the above; showing the ravelling and erosion of the sheared graphitic phyllite which resulted in the development of soil overhang above it.
