Influence of discontinuity sets on slope failures at Pos Selim Highway, Malaysia

AZIMAN MADUN AND HUSAINI OMAR

Abstract: The types of discontinuity of studied slopes are joints and foliations. The discontinuity sets in all the locations have maximum pole intensity of more than 8%. Several sets of discontinuities are recorded at each location. The stereographic plot of the discontinuities set revealed that most of the rock slopes have the potential to fail in the mode of wedge, planar and toppling, as well as the combination of more than one mode of failure. Potential wedge failure is found at seven locations, potential planar failure at five locations and potential toppling at four locations.

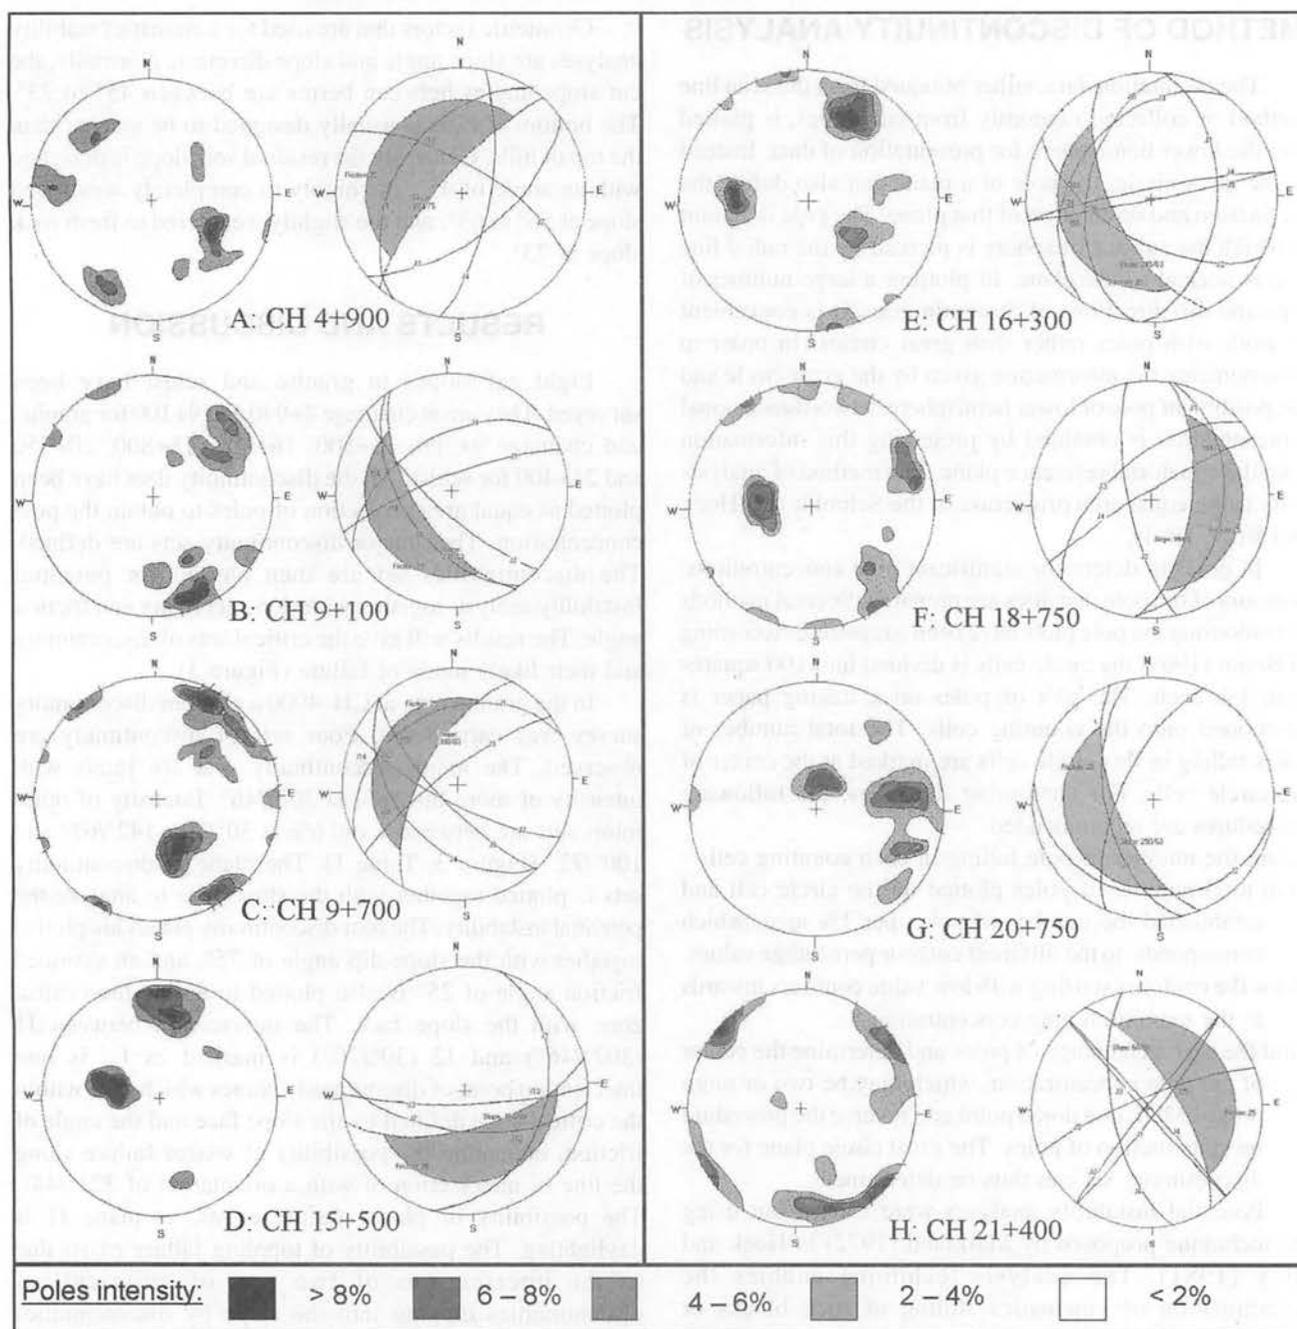
Figure 3: Discontinuity analysis.

In the granite area at CH 4900 a random discontinuity survey was carried out. Four sets of discontinuity are observed. The major discontinuity sets are joints with intensity of more than 8% at 302°/46°. Intensity of other joints sets are between 4 and 6% at 30°/70°, 142°/62° and 100°/72° (Figure 3, Table 1). The plane of discontinuity sets is plotted together with the slope face to analyze the potential instability. The four discontinuity planes are plotted together with the slope dip angle of 75°, and an assumed friction angle of 25° is also plotted to define the critical zone with the slope face. The intersection between J1 (302°/46°) and J2 (30°/70°) is marked as I_{12} is one intersection point of discontinuity planes which falls within the critical zone defined by the slope face and the angle of friction, indicating the possibility of wedge failure along the line of intersection of with a orientation of 321°/44°. The possibility of planar failure exists, as plane J1 is daylighting. The possibility of toppling failure exists due to the intersections of two sets of cross-cutting discontinuities dipping into the slope by discontinuities sets J2 with J3 (142°/62°) and J3 with J4 (100°/72°).

At the cut slope at CH 9100 a random discontinuity survey was carried out. There are four sets of discontinuities. The major discontinuity sets are joints with intensity of more than 8% at 340°/78°. Other joint sets have intensities of between 4 and 6% at 225°/75°, 238°/54° and 330°/50°. The four discontinuity sets are plotted together with the slope angle of 63° and a friction angle of 25°. Two intersection points of discontinuity planes fall within the critical zone defined by the slope face and the angle of friction, indicating the possibility of wedge failure. These are intersection of J1 (340°/78°) and J3 (238°/54°) marked as I_{13} with sliding along 266°/50° and the intersection of J3 and J4 (330°/50°) marked as I_{34} with sliding along of 289°/41°. The possibility of planar failure exists, as plane J3 is daylighting. Plane J2 (225°/75°) is steeper than the slope,

therefore the problem of daylighting does not arise. A possibility of toppling failure also does not exist.

Within the schist area, a scan line discontinuity survey was carried out on the cut slope at CH 9700. There are five sets of discontinuities. The discontinuity sets are designated J1 to J5, based on their equal area intensities. A major discontinuity is foliation, where dip direction and dip is 336°/34° and the equal area intensity is more than 8%. Another major discontinuity with intensity of more than 8% is represented by joints at 210°/76°. Other joint sets which have intensity from 4 to 8% were recorded at 325°/78°, 230°/45° and 230°/75°. The five discontinuity planes are plotted together with the slope dip angle of 63° and an

assumed friction angle of 25° is also plotted. A total of four intersection points of discontinuity planes fall within the critical zone, indicating the possibility of wedge failures. These are the intersection of J1 (336°/34°) and J2 (210°/76°) marked as I₁₂ and sliding along 293°/26°, the intersection of J1 and J4 (230°/45°) marked as I₁₄ and sliding along 291°/25°, the intersection of J1 and J5 (230°/75°) marked as I₁₅ and sliding along 310°/31°, and the intersection of J3 (325°/78°) and J4 marked as I₃₄ with sliding along 230°/45°. The possibility of planar and toppling failure does not exist.

discontinuity sets have been designated J1 to J3. The major discontinuity sets with intensity of more than 8% are foliations at 110°/35° and a joint set at 192°/62°. The intensity of the other joint set is between 6 to 8% at 182°/80°. These three discontinuity planes are plotted together with the slope angle of 63°. A total of two intersection points of discontinuity planes fall within the critical zone defined by the slope face and the friction angle of 25°, indicating the possibility of wedge failure. These are the intersection of J1 (110°/35°) and J2 (192°/62°) marked as I₁₂ with sliding along 122°/34° and intersection of J1 and J3 (182°/80°) marked as I₁₃ with sliding along 100°/34°. However the possibility of planar and toppling failures does not exist.

At the cut slope at CH16300 a scan line discontinuity survey was carried out. The major discontinuity set is foliation with intensity of more than 8% at 96°/48°. Another major joint set is 210°/60°. The intensity of the other joints set are between 2 to 6% at 305°/35°, 350°/85°, 170°/88° and 260°/46°. The six discontinuity planes are plotted together with the slope angle of 63°. A total of four intersection points of discontinuity planes fall within the critical zone defined by the slope face and the friction angle of 25°, indicating the possibility of wedge failures. These are the intersection of J2 (210°/60°) and J3 (305°/35°) marked as I₂₃ with sliding along 305°/35°. Intersection of J2 and J4 (350°/85°) marked as I₂₄ with sliding along 266°/46°. Intersection of J2 and J6 (260°/46°) marked as I₂₆ with sliding along 266°/46°. Intersection of J5 (170°/88°) and J6 marked as I₅₆ with sliding along 258°/46°. Furthermore there exists the possibility of planar failure, as there are discontinuity planes parallel and subparallel to this slope. As the plane J2 is daylighting planar failure is possible. The possibility of toppling failure are due to the intersections of two sets of cross-cutting discontinuities dipping into the slope these are the discontinuities sets J1 (96°/48°) with J2, J1 with J3 (305°/35°) and J1 with J5.

A scan line discontinuity survey was carried out at cut slope CH18750. There are four sets of discontinuities. The major discontinuity set is foliation with more than 8% intensity is marked as 102°/40°. Other joint sets have intensities of between 4 to 8% at 260°/46°, 320°/60° and 330°/85°. The four discontinuity planes are plotted together with the slope dip angle of 63° and a friction angle of 25°. Only one intersection between J1 (102°/40°) and J4 (330°/85°) marked as I₁₄ with sliding along 57°/31° falls within the critical zone, indicating the possibility of wedge failure. The possibility of planar failure also exists, as the plane J1 is daylighting. The possibility of toppling failure exists due to the intersections of two sets of cross-cutting discontinuities dipping into the slope. These are the discontinuity sets J2 (260°/46°) with J3 (320°/60°) and J2 with J4.

than 8% intensity, marked as 260°/56°. Other sets are foliation with between 6 and 8% intensity at 190°/20°, and joints at 295°/66° with intensity of 4 to 6%. The three discontinuity planes are plotted together with the slope dip angle of 63° and a friction angle 25°. The possibility of wedge failure does not arise as there is no intersection of discontinuities and therefore the slope is stable with respect to such failure. But the possibility of planar failure exists, as the plane J1 (260°/56°) is daylighting. The possibility of toppling failure does not exist.

A scan line discontinuity survey was carried out at CH 21400. There are 6 sets of discontinuities, and 2 sets have intensities of more than 8% at 130°/85° and 310°/88°. The others have intensities of between 6 and 8% at 230°/88°, 50°/88°, 340°/80° and 260°/65°. All the discontinuity sets are joints. The six discontinuity planes are plotted together with the slope dip angle of 68° and a friction angle of 25°. Only one intersection point fall within the critical zone. This is the discontinuity set J1 (130°/85°) and J5 (340°/80°) marked as I₁₅ with sliding along 52°/62°, indicating the possibility of wedge failure. The possibility of planar

failure does not exist. There were four possibilities of toppling failures due to the intersections of two sets of crosscutting discontinuities dipping into the slope. There are J1 with J3 (230°/88°), J1 with J6 (260°/65°), J3 with J5 (340°/80°) and J5 with J6.
