Engineering geology of slopes for the preparation of EIA reports – A case study from the proposed site for a national secondary school at Ringlet, Pahang Darul Makmur

TAJUL ANUAR JAMALUDDIN¹ AND AHMAD NIZAM HASSAN²

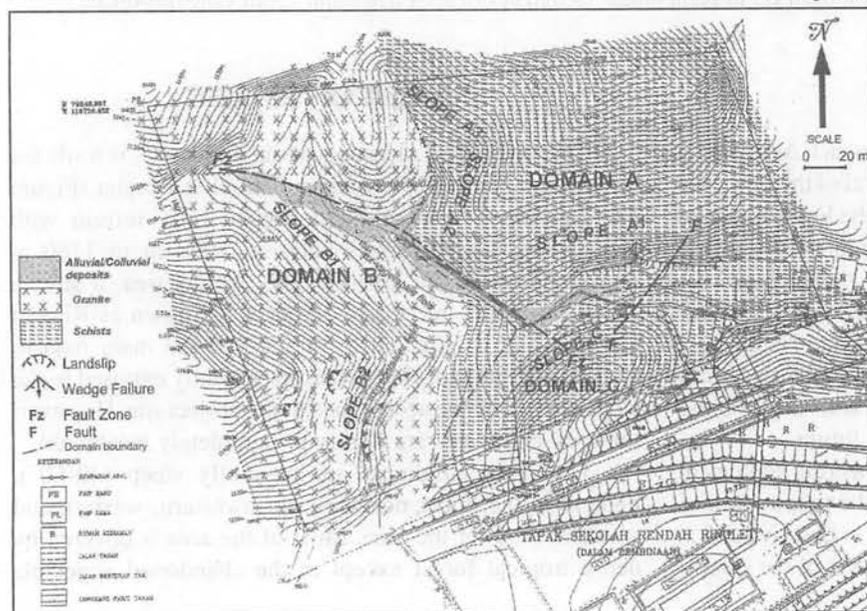
Figure 2. General geological map of the study area.

The general geology of the site is shown in Figure 2. The bedrock of the project site comprises metamorphic and igneous rocks. The metamorphic rocks consist predominantly of schist. The exposed schists are highly to completely weathered, light brownish grey to greyish brown in colour, fine to medium grained and very well foliated. In hand specimens, the schist composed essentially of quartz and mica, with smooth and shiny foliation surfaces. In places, traces of original bedding are still visible, which is almost parallel to the foliation, suggesting that the schist was originally a sedimentary rock. Schist forms about two-thirds of the project site, notably in the central and eastern portions of the area.

Domain A is further divided into 3 sections, namely Slope A1, Slope A2 and Slope A3, based on their average orientation. Their locations are indicated in Figure 2. General orientation (strike/dip) of Slope A1, Slope A2 and Slope A3 is $082^\circ/45^\circ\text{S}$, $195^\circ/45^\circ\text{W}$ and $128^\circ/40^\circ\text{SW}$, respectively.

orientation. Their locations are indicated in Figure 2. The average orientation (strike/dip) of Slope B1 and Slope B2 are 320°/40°E and 021°/42°E, respectively.

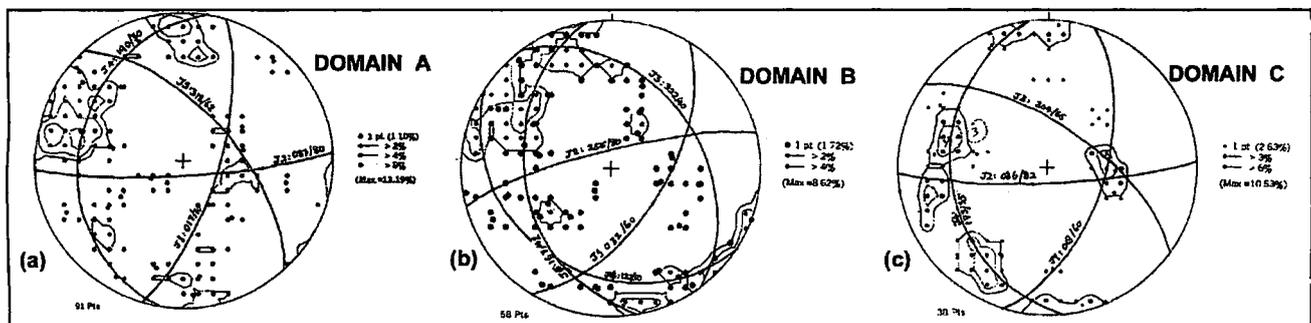
Figure 3. Lower hemisphere stereographic projections of pole to discontinuities in a) Domain A; b) Domain B and c) Domain C.

Domain A comprises the hill slopes to the north of the main valley. Structural data were collected from the highly to completely weathered cut slopes in schist along the access road. Stereographic plot of the discontinuity data (Figure 3a) indicates that the rock mass in Domain A contains at least 4 sets of discontinuities (Table 1).

Domain B comprises the hill slopes in granite at the northwest and west of the project site. Structural data was mainly collected from the relict structures preserved in the completely weathered cuts in the lower hill slopes in the abandoned vegetables fields. Stereographic plots of the discontinuity data (Figure 3b) indicates that the rock mass is affected by at least 5 sets of joints. Some of the joints are however randomly oriented and could not be easily grouped into any one of the five sets identified (Table 1).

Domain C comprises the hill slopes in the southern part of the project site, with similar lithology as Domain A. Structural data was collected from the available cut slopes along the access road and along the earth ditch. The exposed rock is highly to completely weathered schist. Stereographic plot (Figure 3c) indicates that the structural discontinuity in Domain C is almost similar to those in Domain A (Table 1).

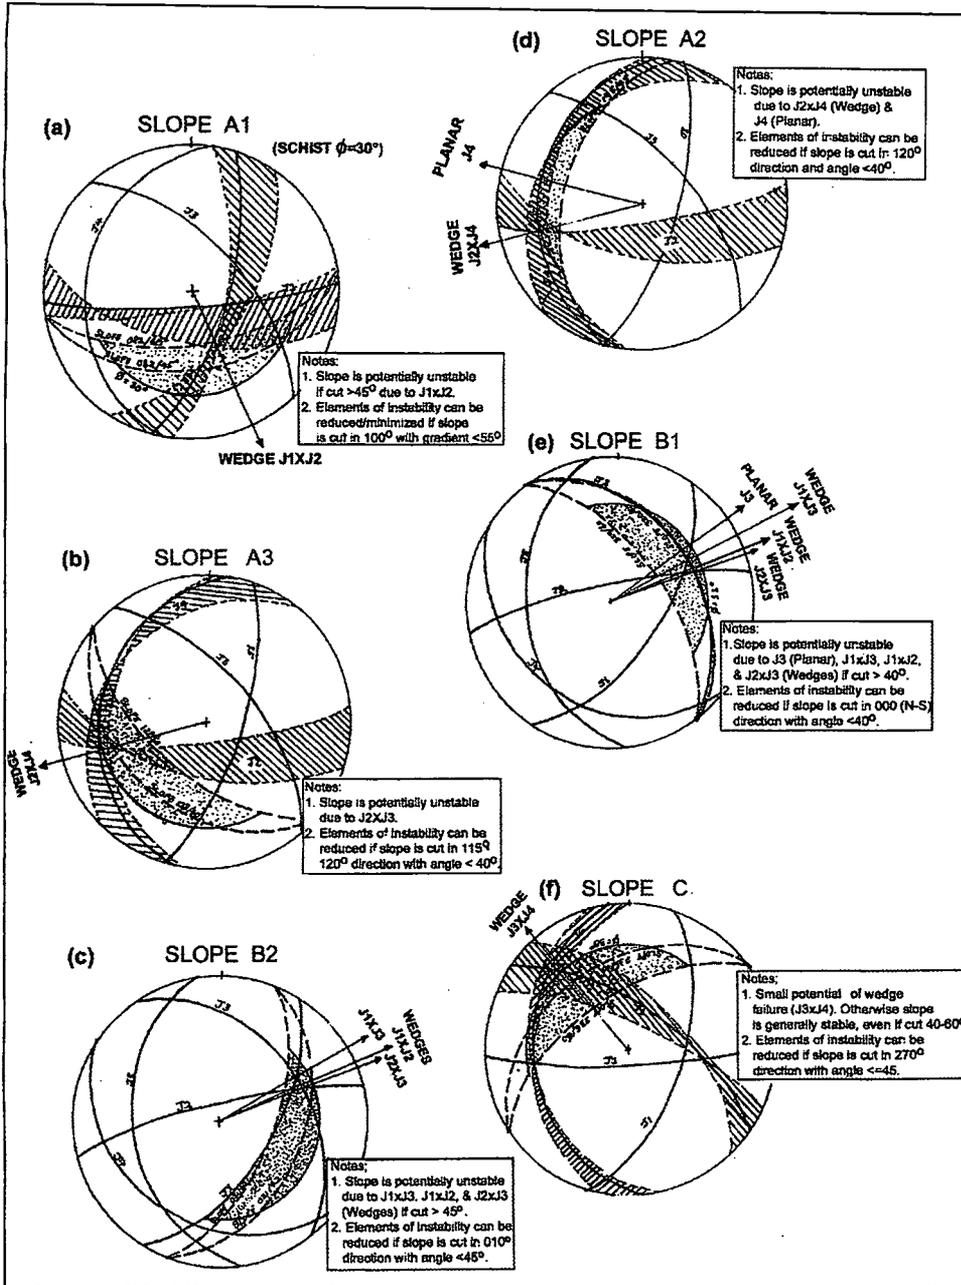
Figure 5. Kinematic stability analyses of the existing slopes in the study area.

Results of kinematic stability analysis suggest that the existing Slope A1 is not likely to fail. However, if the slope is cut steeper than 45° , it will have a potential to fail in wedge failure due to the intersection of J1 and J2 (Figure 5a). This is evident in the field, where the existing cut slope with 65° angle has undergone wedge failures. This problem can be minimised by making the cut slope angle gentler than 55° with strike maintained at 100° .

Slope A2 also has a potential to undergo wedge failure due to the intersection of J2 and J4 (Figure 5b). Because some of the joints in set J4 are daylighting towards the slope face, they may also cause planar or sliding failure. To minimise such risks, it is recommended that any future cut slope in Slope A2 should be cut gentler than 40° with the slope faces striking in 120° direction.

Slope A3 also has the potential to undergo wedge failure due to the intersection of J2 and J4 (Figure 5c). This problem can be reduced by making the slope angle gentler than 40° and the slope is cut in 115° - 120° direction.

Slope B1 has the potential to undergo wedge failure due to intersections of J1, J2 and J3 (Figure 5d). Joint set J3 is considered critical as it is daylighting towards the slope face, and thus has a potential to cause planar or sliding failure as well. The potential of failures is greatly increased if the slope is cut steeper than 45°. Elements of instability may be greatly reduced if the slope is cut in the north-south direction and the slope angle is less than 40°.

Under existing conditions (angle \leq 42°), Slope B2 shows no signs of major instability. However, if the cut slope made steeper than 50°, the slope has the potential to undergo wedge failure due to intersections of J1, J2 and J3 (Figure 5e). Elements of instability can be reduced if the slope is cut in 010° direction and the slope angle is less than 45°.

Domain C slopes are relatively small and their heights are generally less than 30 m. By assuming the average slope orientation of 240°/40°N (Slope C), results of the kinematic stability analysis (Figure 5f) indicates that the slope has the potential to experience wedge failure due to intersections of J3 and J4. Elements of instability can be reduced if the slope is cut in 270° direction and the slope angle is less than or equal to 45°.
