Relict Structures and Cut Slope Failures in Highly to Completely Weathered Rocks Along Jalan Tg. Siang, Kota Tinggi, Johor

TAJUL ANUAR JAMALUDDIN & MUHAMMAD FAUZI DERAMAN

Department of Geology, University of Malaya
50603 Kuala Lumpur, Malaysia

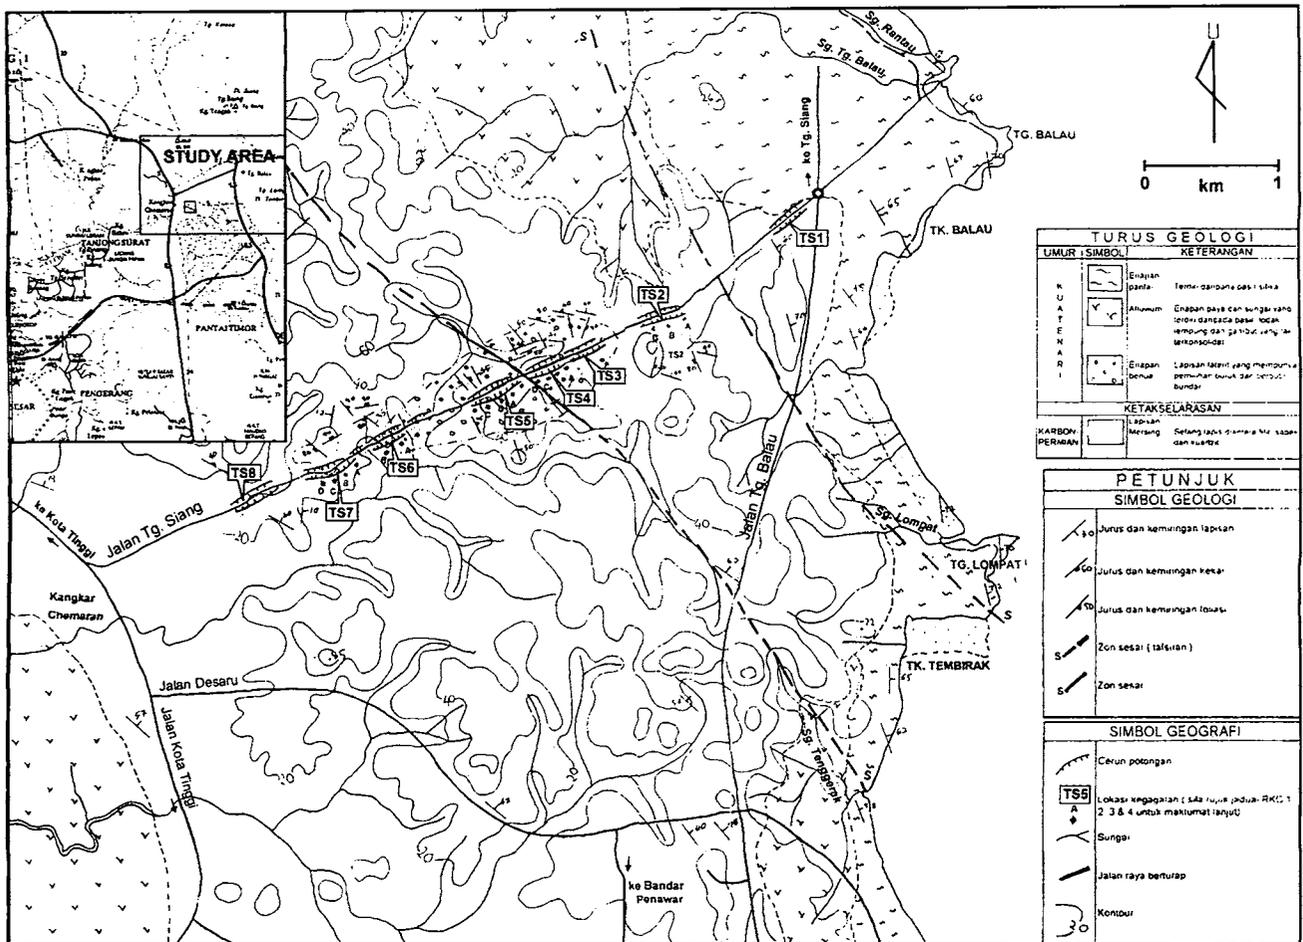
The location of failures are shown in Figure 1. Details of the geology, slope geometry, mode of failure and the likely causative factors are summarised in Table 1. Failures of cut slopes in the study area usually take place in the form of "soil" ravelling, erosion and undercutting-induced failures. Ravelling and erosional failures usually develop preferentially within shear zones, where the materials are relatively loose, friable, very weak, less durable and characteristically unfavourable for growth of vegetation (Figure 2).

Figure 1: Simplified geological map of Jalan Tg. Siang, showing the locations of cut slope failures (largely after Muhammad Fauzi Deraman, in prep.)
