Rainfall and Slope Failures in the Granitic Bedrock Areas of Peninsular Malaysia

J. K. RAJ

Abstract

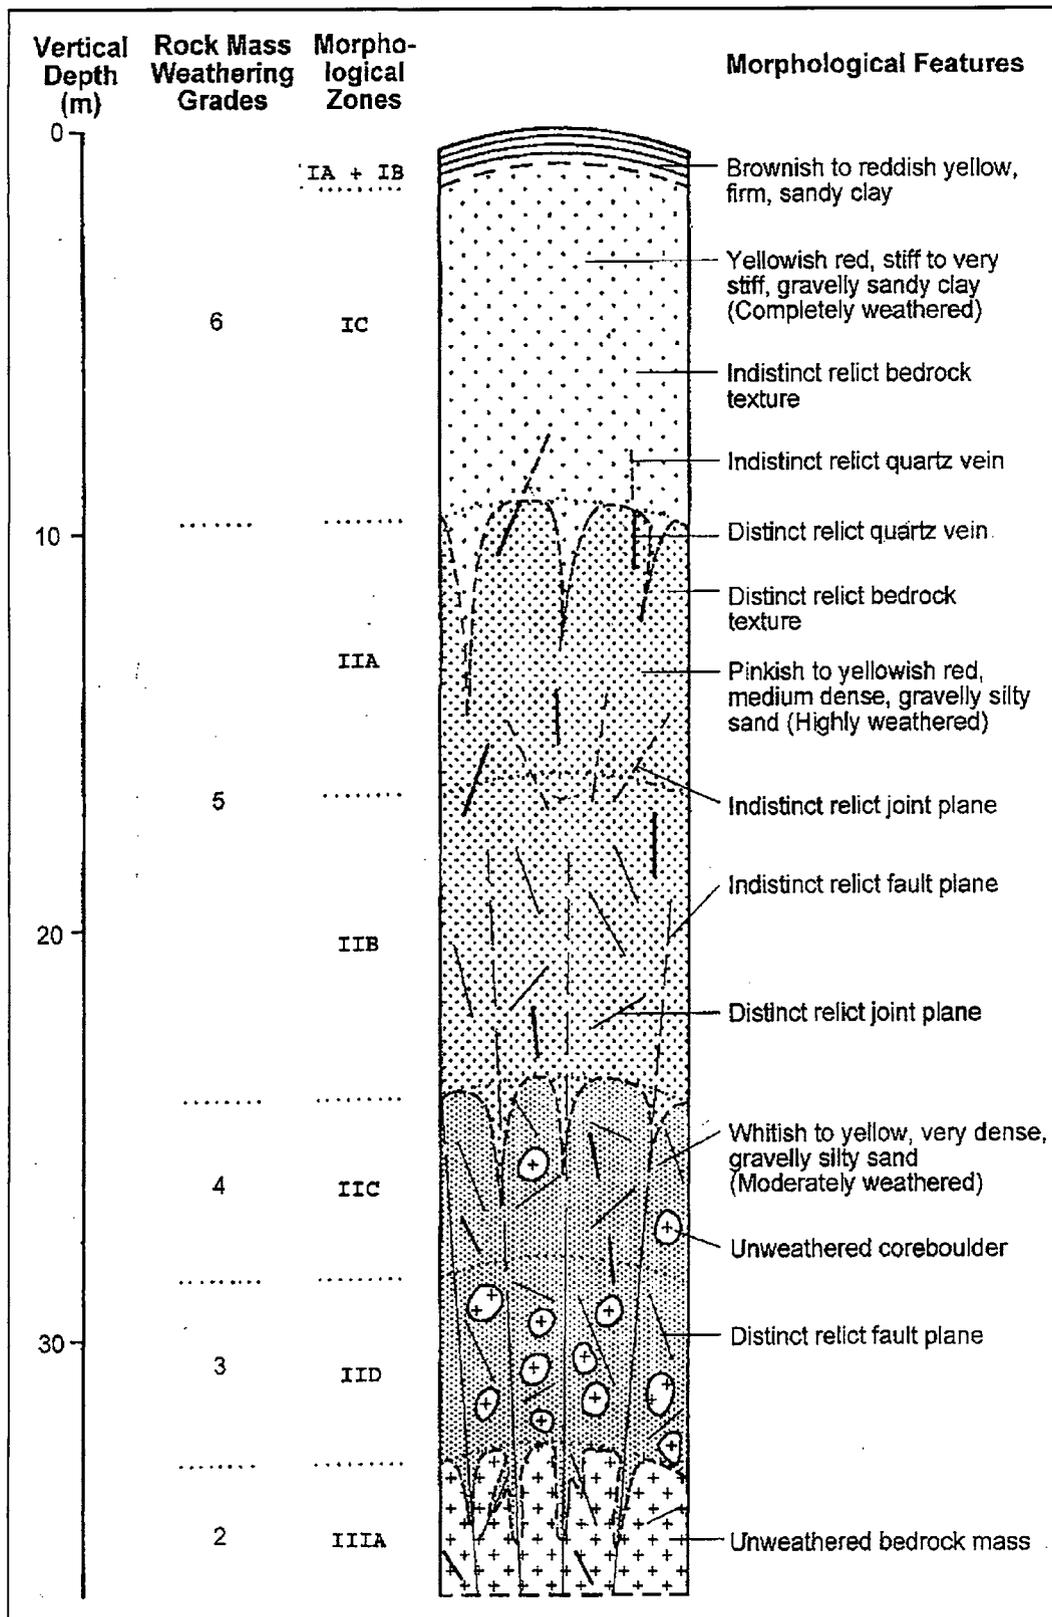
Figure 1: Weathering profile over porphyritic biotite granite.

In the case of a typical weathering profile developed over a porphyritic biotite granite (Fig. 1), the topmost Zone I (Grade 6) is up to 10 m thick and consists of completely weathered bedrock materials that indistinctly preserve the textures, but not structures, of the original bedrock. The weathered materials have been subject to pedological processes and can be separated into an upper, friable sandy clay IA horizon, an intermediate, firm, sandy clay IB horizon, and a lower, stiff to very stiff, gravelly sandy clay, IC horizon.

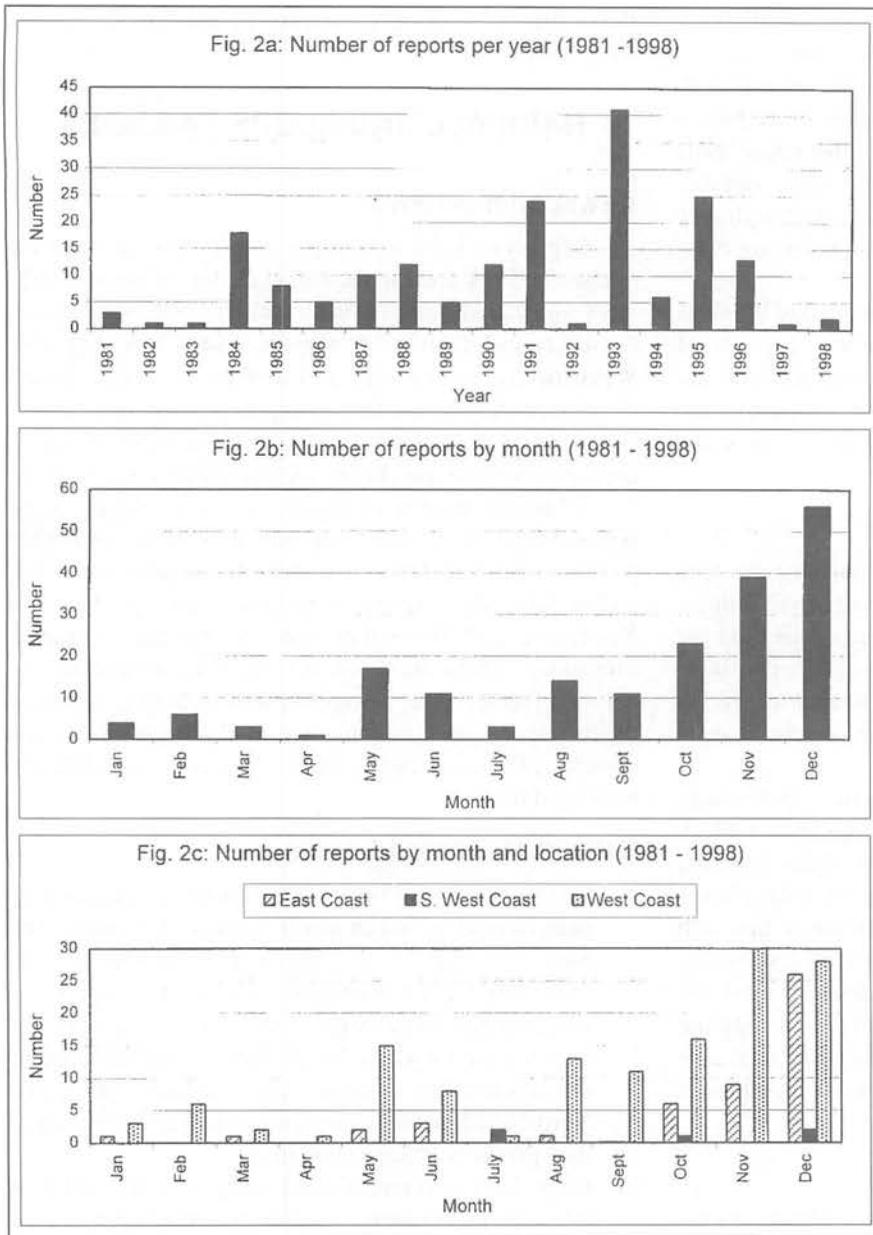
Figure 2: Local newspaper reports on slope failures in the granitic bedrock areas of Peninsular Malaysia (1981-1998).

Reports in local newspapers of slope failures in the granitic bedrock areas of the Peninsula for the period 1981-1998 show a disproportionate pattern with some years having considerably more reports than others (Fig. 2a). When this pattern is compared with the total annual rainfall of selected stations for the same period, there is a distinct correlation with the years having a large number of reports coinciding with the years having relatively high annual rainfalls.

When the number of reports per month for the same period (Figs. 2b & 2c) is examined, a distinct monthly pattern is seen with few reports between January and April, and in July. Most reports of the East Coast are found in November and December (i.e. during the Northeast Monsoon), whilst those of the West Coast are mostly between October and December, and in May (i.e. during the two periods with maximum rainfall). Slope failures are therefore, to be associated with the months having relatively high rainfalls.
